SERVICE BULLETIN ASM-015

Product: Antenna System Monitor

Subject: Firmware 2.50e Release

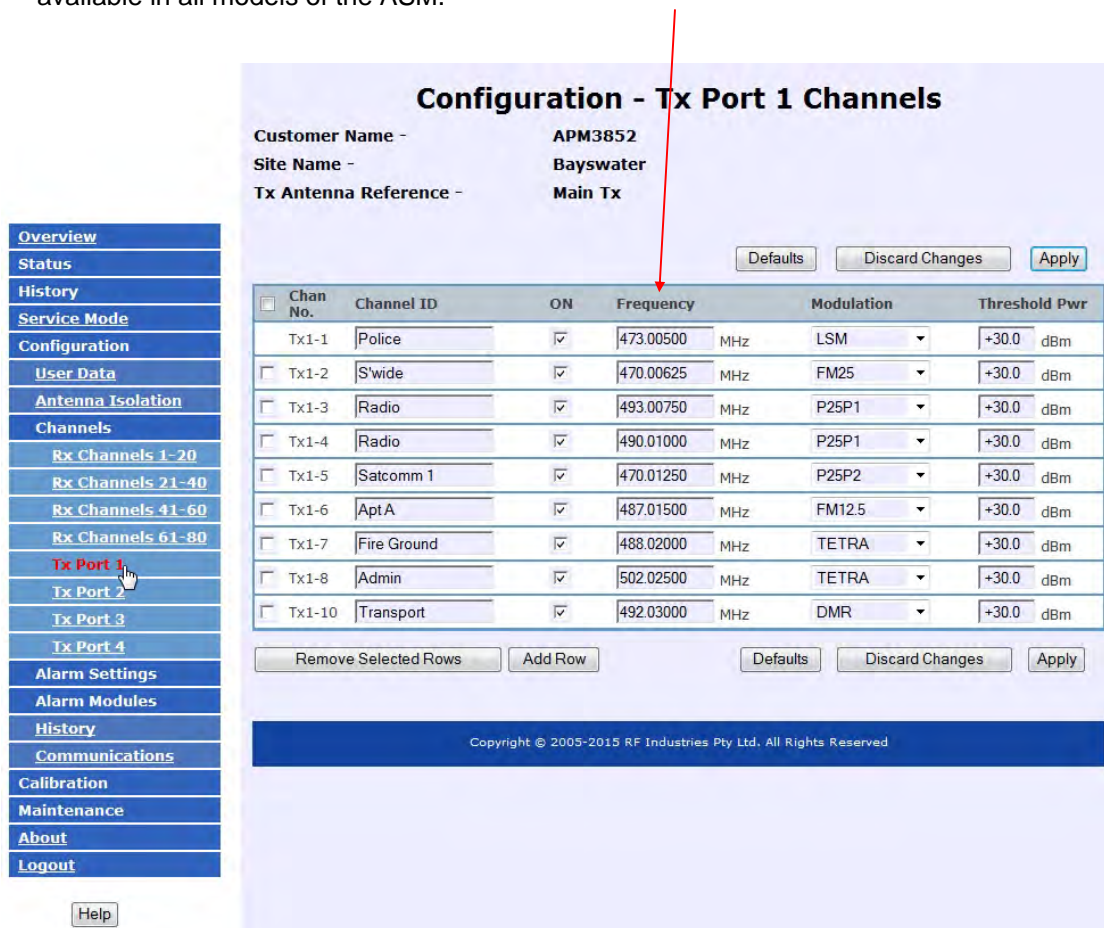
ii) 1.25KHz Channel Frequency Step Size

Channel frequencies on any 1.25KHz multiple can now be programmed into the ASM. This feature allows 5KHz, 6.25KHz, 7.5KHz, 10KHz, 15KHz, 20KHz and 30KHz channel frequency steps to be catered for. This feature is more commonly required in the VHF band, but is made available in all models of the ASM.

Chan No.	Channel ID	ON	Frequency	Modulation	Threshold Pwr
<input checked="" type="checkbox"/>	Tx1-1 Police	<input checked="" type="checkbox"/>	473.00500 MHz	LSM	+30.0 dBm
<input type="checkbox"/>	Tx1-2 S'wide	<input checked="" type="checkbox"/>	470.00625 MHz	FM25	+30.0 dBm
<input type="checkbox"/>	Tx1-3 Radio	<input checked="" type="checkbox"/>	493.00750 MHz	P25P1	+30.0 dBm
<input type="checkbox"/>	Tx1-4 Radio	<input checked="" type="checkbox"/>	490.01000 MHz	P25P1	+30.0 dBm
<input type="checkbox"/>	Tx1-5 Satcomm 1	<input checked="" type="checkbox"/>	470.01250 MHz	P25P2	+30.0 dBm
<input type="checkbox"/>	Tx1-6 Apt A	<input checked="" type="checkbox"/>	487.01500 MHz	FM12.5	+30.0 dBm
<input type="checkbox"/>	Tx1-7 Fire Ground	<input checked="" type="checkbox"/>	488.02000 MHz	TETRA	+30.0 dBm
<input type="checkbox"/>	Tx1-8 Admin	<input checked="" type="checkbox"/>	502.02500 MHz	TETRA	+30.0 dBm
<input type="checkbox"/>	Tx1-10 Transport	<input checked="" type="checkbox"/>	492.03000 MHz	DMR	+30.0 dBm
